Case study of Donjek debris flow, southwest Yukon

David P. Van Zeyl¹ and J. Graham Cogley
Department of Geography, Trent University²

Van Zeyl, D.P. and Cogley, J.G., 2005. Case study of Donjek debris flow, southwest Yukon. *In: Yukon Exploration and Geology 2004*, D.S. Emond, L.L. Lewis and G.D. Bradshaw (eds.), Yukon Geological Survey, p. 247-257.

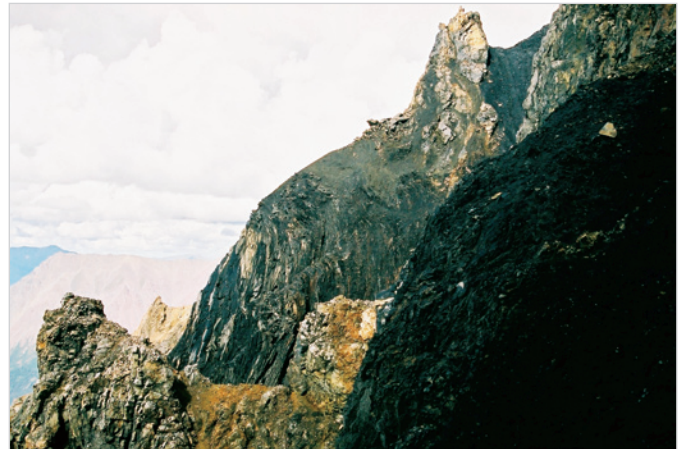
Figure 2. Deeply weathered loose dark and icy soil in the basin amongst vertically bedded limestone units. View looks toward the Donjek River from the north slope of the basin.

Most soil in the basin is poorly consolidated, dark coloured and contains variable amounts of ice (Fig. 2). A veneer of light beige colluvium covers the southeast-facing slope. The soil on the northwest-facing slope is

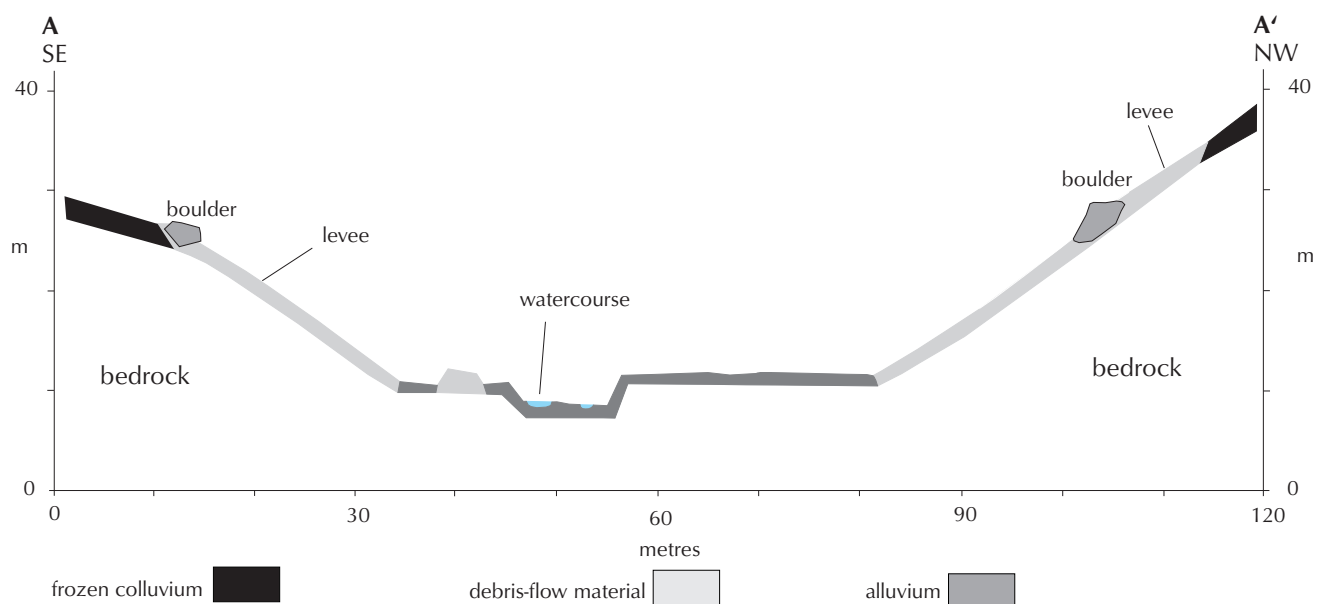
Figure 5. Cross-section in the gorge where peak discharge was calculated. The location of this cross-section is shown on Figure 3.

Debris-flow peak discharge is estimated using cross-sectional area and velocity. It is important that the cross-sectional area is calculated at a location in the confined gorge where levees are formed on both walls (Fig. 5). Jakob et al. (2000) note two reasons why calculating peak

discharge from the product of cross-sectional area and velocity can be problematic. First, the cross-sectional area can be inaccurate because of scour or deposition after the debris flow. Second, cross-sectional area measured at channel bends may be greater than that measured where the channel is straight. In the case of the Donjek debris flow, there is material within the cross-section (Fig. 5) that could be from a subsequent debris flow or snow avalanche. Additionally, as discussed earlier, the watercourse has lowered the channel bed. An attempt was made to determine the original cross-sectional area at this location by estimating the amount of material removed by scour or added by deposition. A conservative estimate of the original cross-sectional area of the debris flow is 80 m². The fact that the location of the cross-section is in a part of the gorge that is straight for approximately 480 m increases the confidence of this area estimate.

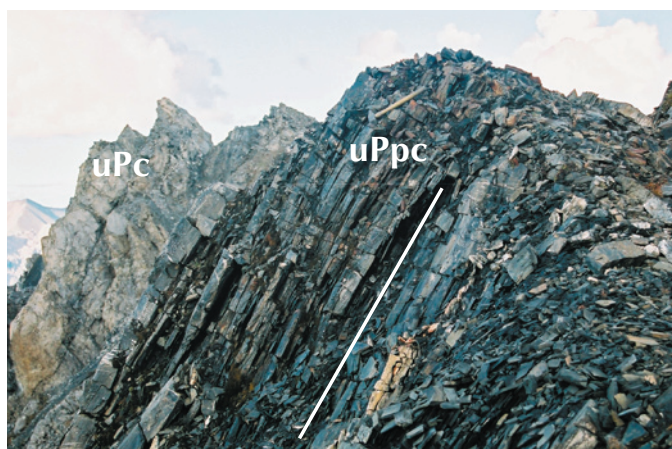
Figure 7. Photo of bedding and foliation planes in siltstones and argillites at the headscarp. Rock hammer for scale.

headscarp structure dips 65° to the north-northwest (Fig. 7), which is oblique to the valley axis. The sediments in the wedge-shaped depression appear remarkably similar to those found on the debris flow. Furthermore, argillite and siltstone-argillites with minor dark blue-grey limestone bands outcrop in the wedge-shaped depression (Fig. 6). At the scarp, siltstones are the dominant lithology.
